AHERA 3-Year Asbestos Re-Inspection

Denver Waldorf School
940 Fillmore Street
Denver, Colorado 80206

Report Date: November 20, 2013

OEI Project No. 13.159

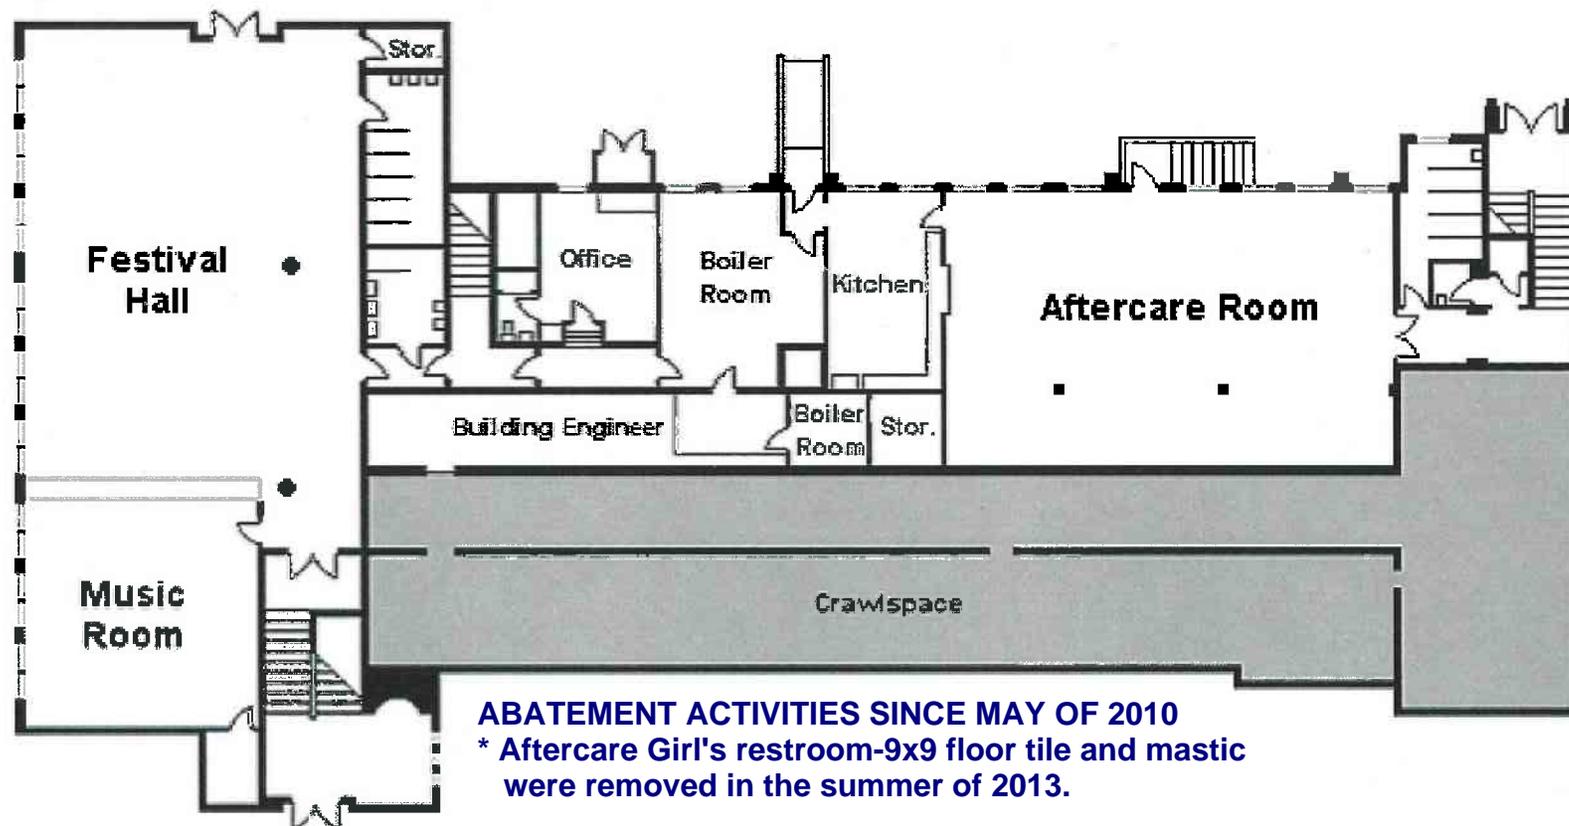
Lower Level Floor Plan

*Floor tile and mastic was removed from the Science Lab in the summer of 2013
